Howard Road Historic District
Isaac Boston House
1004 Howard Road
Washington
District of Columbia

HABS No. DC-395-B

ARCHITECTURAL DATA FORM

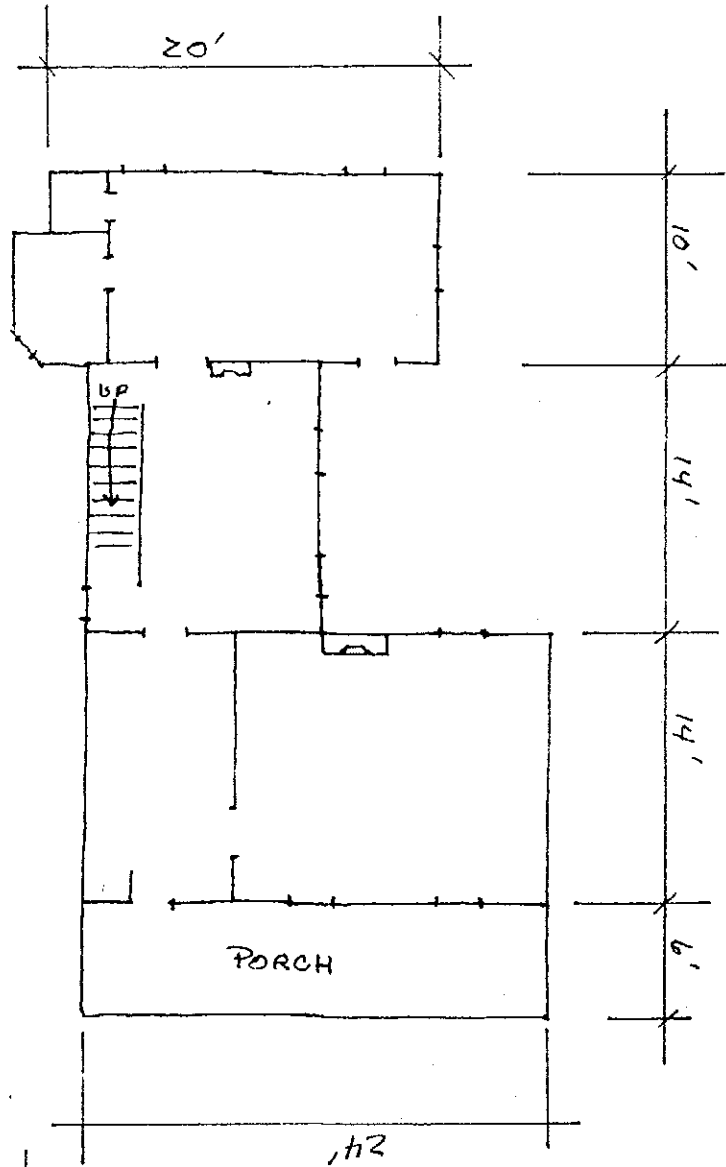
FIRST FLOOR

SHAPE AND DIMENSIONS OF STRUCTURE (SKETCHED FLOOR PLANS ON SEPARATE PAGES ARE ACCEPTABLE) (see sketched floor plan); two stories, side-gable single-pile main block and two-story rear ell, overall dimensions 24' x 44'; one-story shed-roofed kitchen unit across rear		
EXTERIOR FEATURES OF NOTE Full-length front porch with factory-turned posts; 6/6 wood d.h.s., cornice broken with triangular gable above entrance; three-bay facade, entrance to left of center, features glazed transom panel.		
INTERIOR FEATURES OF NOTE (DESCRIBE FLOOR PLANS, IF NOT SKETCHED) Staircase in rear ell features square balusters and newel with chamfered top corners and turned ball finial; wooden fireplace mantel in living room has turned and reeded elements and console brackets; reeded door surrounds present in first floor front rooms.		
MAJOR ALTERATIONS AND ADDITIONS WITH DATES 1905- roof of rear wing raised 3 feet dates unknown- 1-story, slant-roofed kitchen unit added at rear; house covered with synthetic shingle siding
